**McKenzie Interchange Highway Improvement Project, Colquitz River and
Cuthbert Holmes Park Culvert Outfall and Riparian Mitigation and
Restoration
Prescription Summary and Environmental Construction Workplan**

Prepared by:
Sean Wong, Senior Biologist

V 1, May 2019

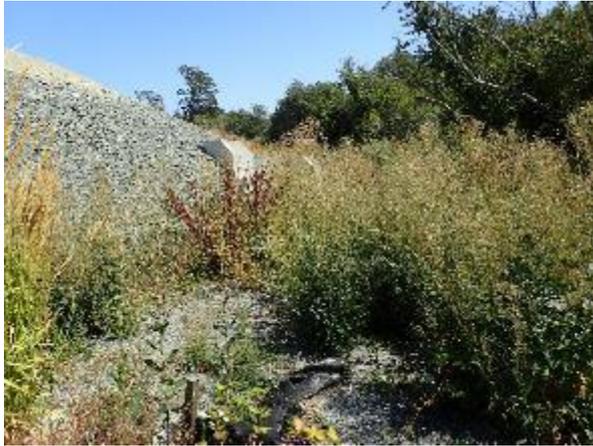
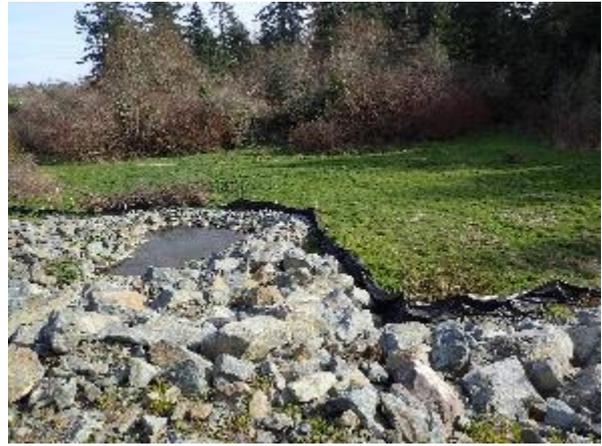
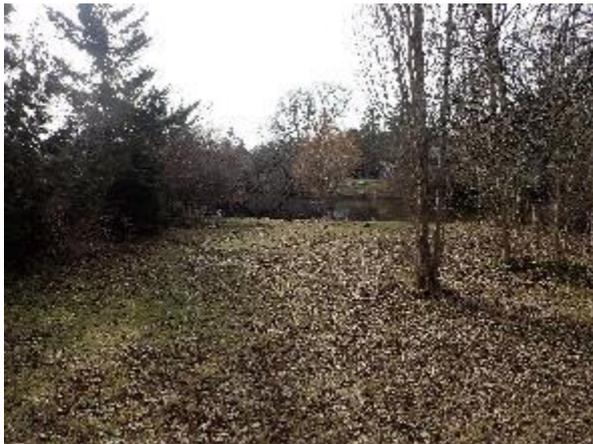
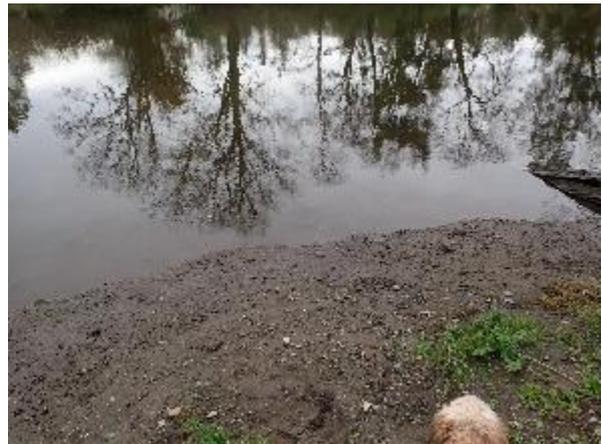
Pre-restoration photos of impaired areas targeted for restoration. From top left and clockwise: Partial Cloverleaf Outfall Area, E Outfall, Colquitz River Mainstem Infill and Colquitz River Grassy Riparian Zone

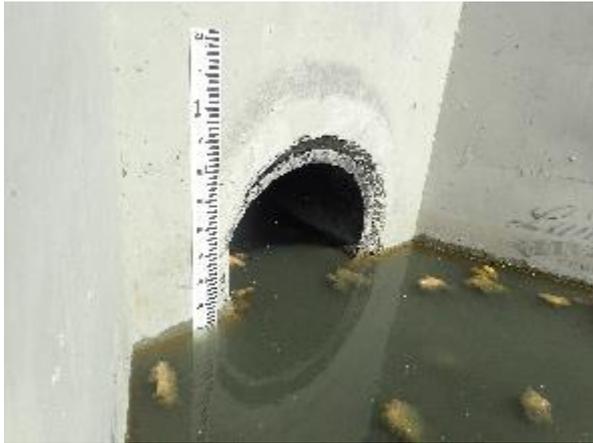
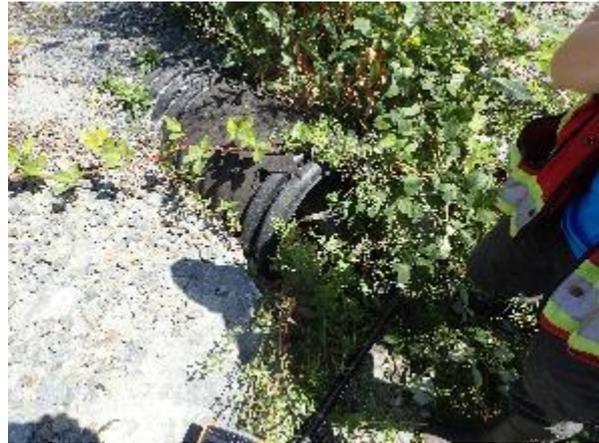
Standing water was observed at the lower parcel culvert outfall and a trickle inflow at a temporary black HDPE pipe on Aug. 1, 2018 after no summer rain and prevailing hot weather. This moisture regime and inflow suggests a good opportunity for wetland and riparian habitat creation.

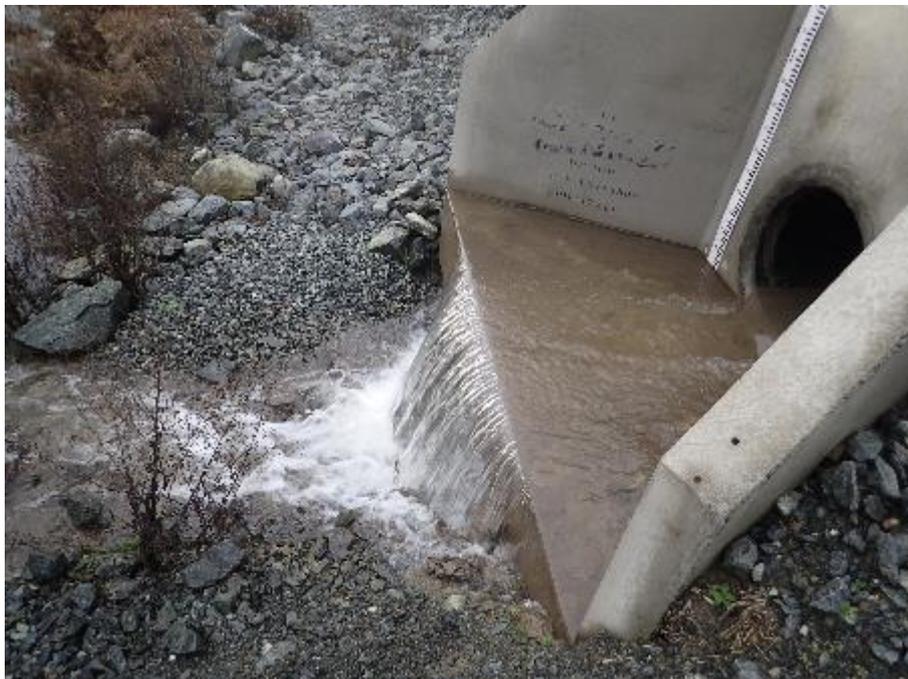
Undermining of the concrete apron of the higher elevation parcel outfall will be remediated by placement of keyed-in riprap for a short, armoured spillway in the erosion area under the apron about 2-3m long with a rough rock surface for increased turbulence, aeration and energy dissipation.

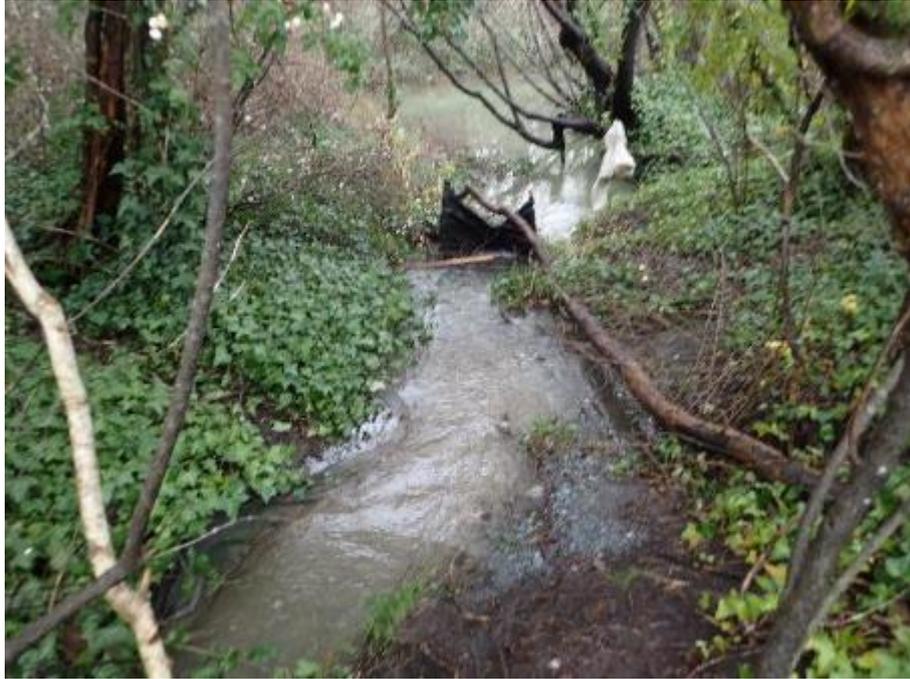
Downstream view along parclo outfall channel through riparian zone during high runoff and close to a King tide with backflooding effects. The high runoff has not demonstrated a need for a hard-engineered armoured channel through this zone and it is expected the proposed green treatment is a much better environmentally friendly option.

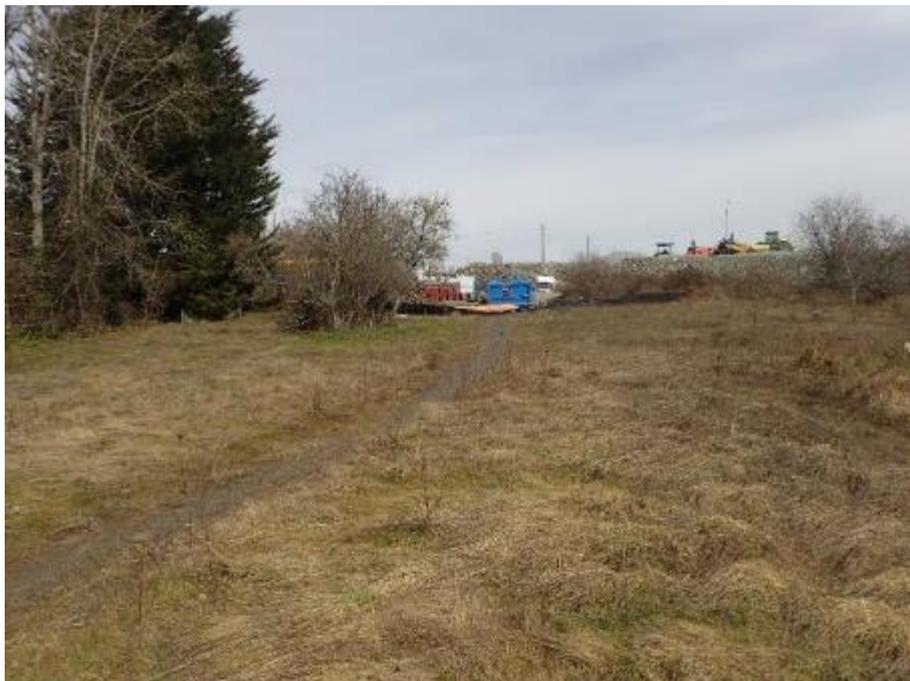
View from CHP target restoration site toward MIP showing historically cleared/disturbed ground with low biodiversity values and a possible machine access site off the existing construction staging area to the E of Admirals Road. A machine access and staging and stockpile area has been created in the Himalayan blackberry and grass meadow patch toward the NW or top right of the photo.

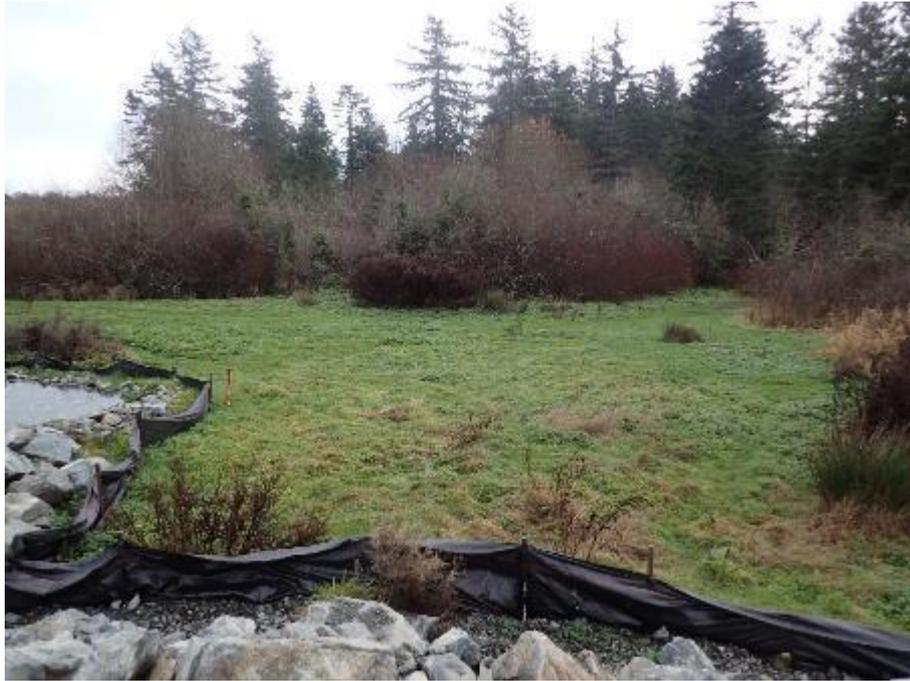
View from highway embankment toe SE toward grass and weed (many buttercups) dominated meadow targeted for a ~500m+ wetland pond water quality treatment and wildlife feature. Some of the shrub border is English hawthorn and these type of non-native or invasive vegetation may also be removed for this restoration.

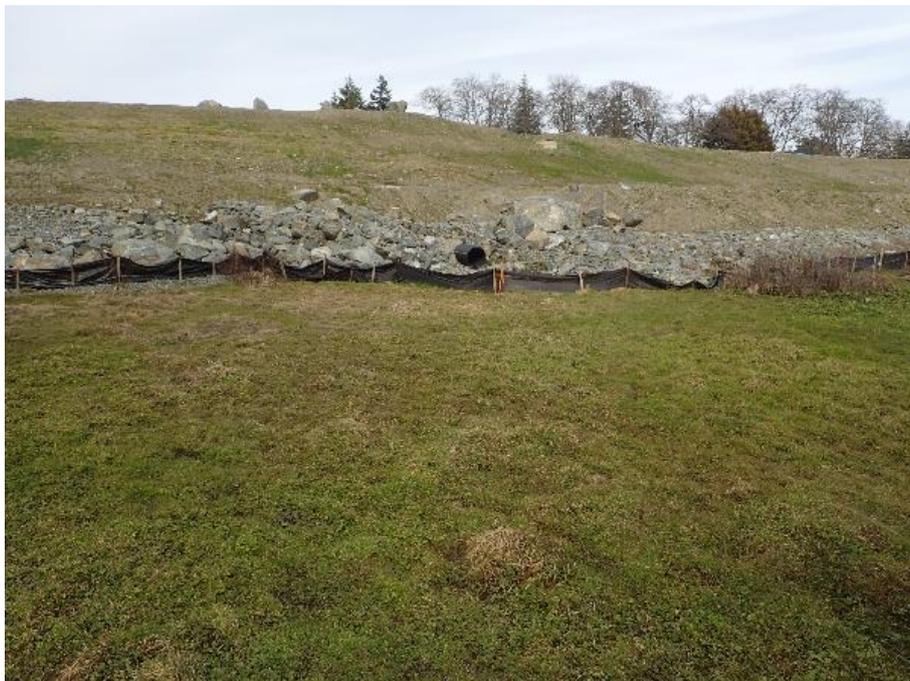
View from meadow toward E outfall. The meadow are has always had visible surficial moisture and feels spongy underfoot.

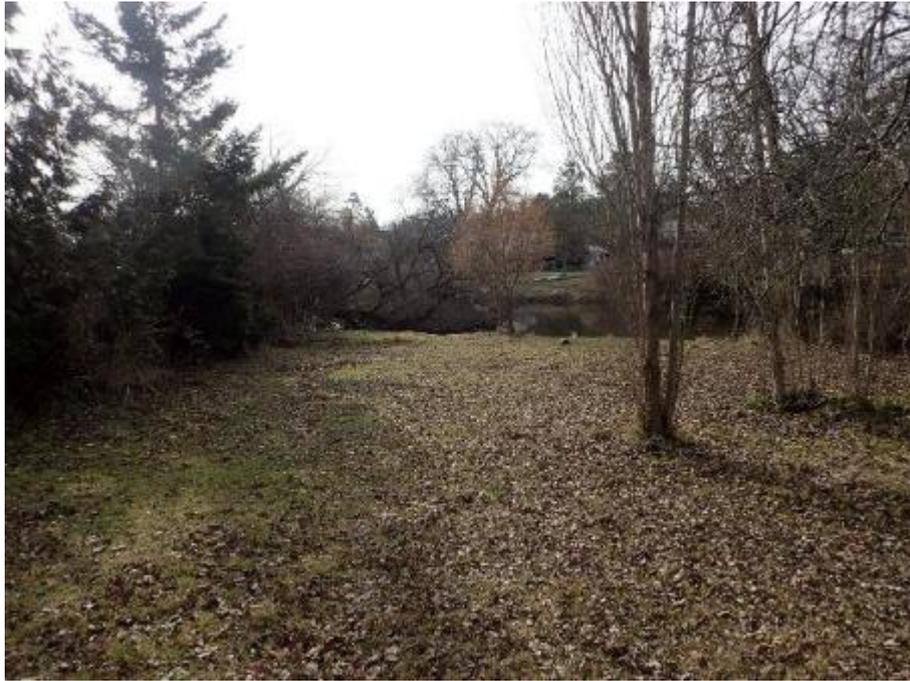
View S toward Colquitz River from lot near the Admirals Road Bridge showing the grassy clearing that could benefit from increased soil scarification or soil addition, riparian plantings, discrete tidal dendritic channel and marsh bench construction and instream and terrestrial habitat complexing.

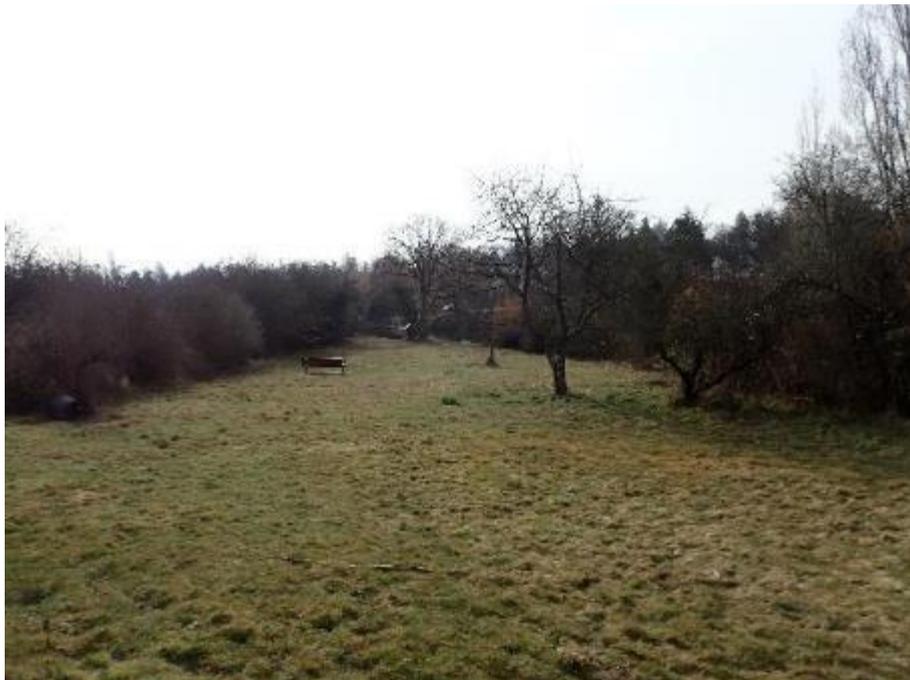
View toward Colquitz River from lot near Admirals Road shows historically cleared ground with grassy areas having low biodiversity value and beneficial for riparian and habitat complexing treatments.

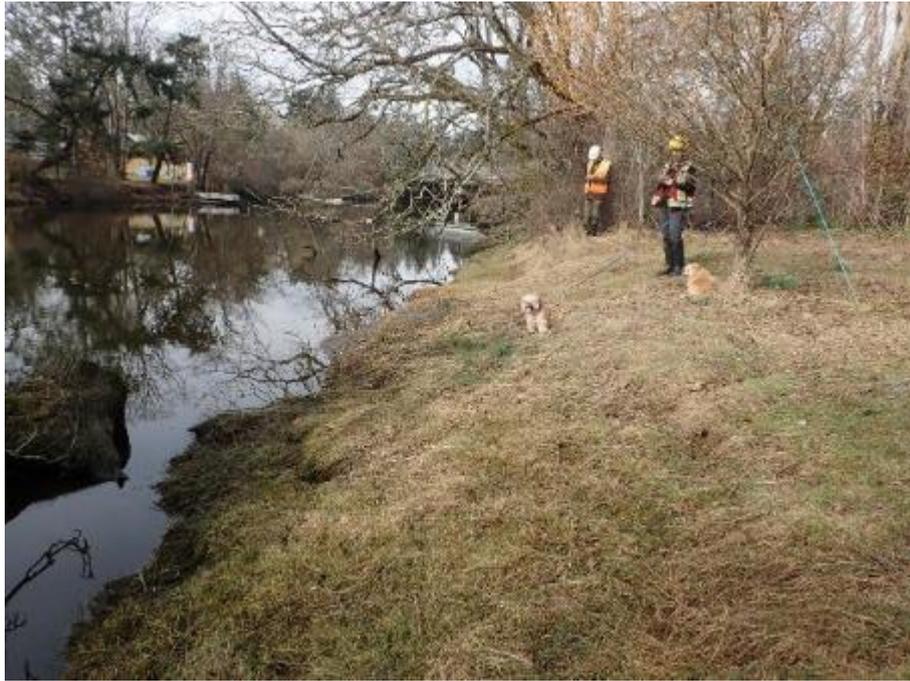
Tidally influenced area upstream of Colquitz Admirals Road Bridge has low value riparian that would benefit from increased native vegetation for shade cover and other riparian benefits. Many of these areas from E of Admirals to the tidal channel from the parclo outfall are readily accessible by equipment, which enables more intensive and larger scale restorative measures, including woody debris complexing, excavation, placement of soil for enhanced planting medium, instream gravel placement and dendritic channel and marsh bench construction.

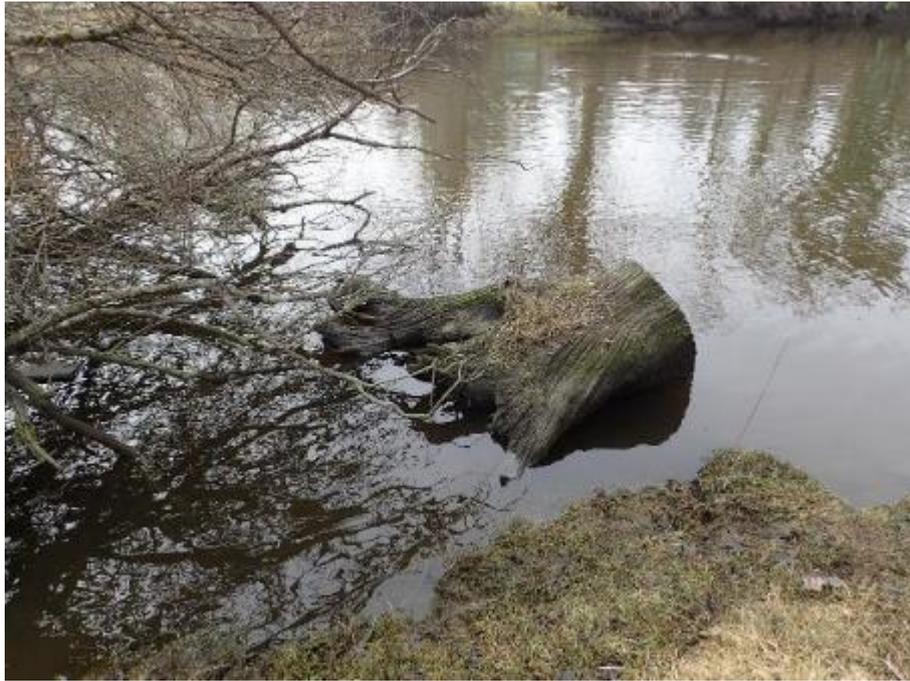
Some shrub cover and woody debris exists along the right bank and adds habitat complexity and addition of more of these types of features are recommended.

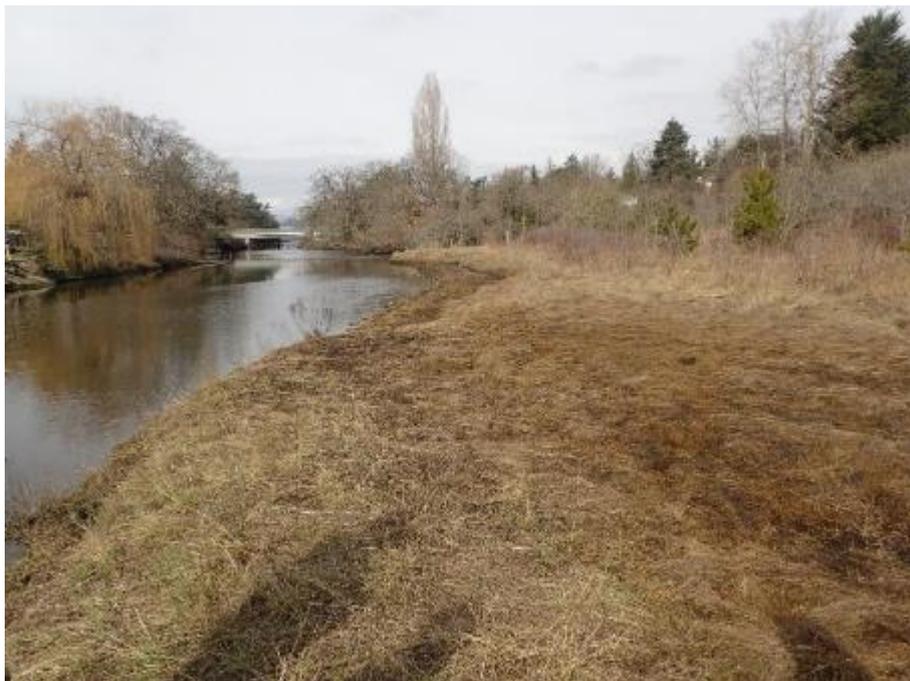
View to the W toward Admirals Road Colquitz Bridge. Gabion baskets are under the lower tidal bench and beside an associated riparian replacement zone, somewhat delineated by the lower growing conifer/pine trees. Much more of this area could use similar native riparian plantings.

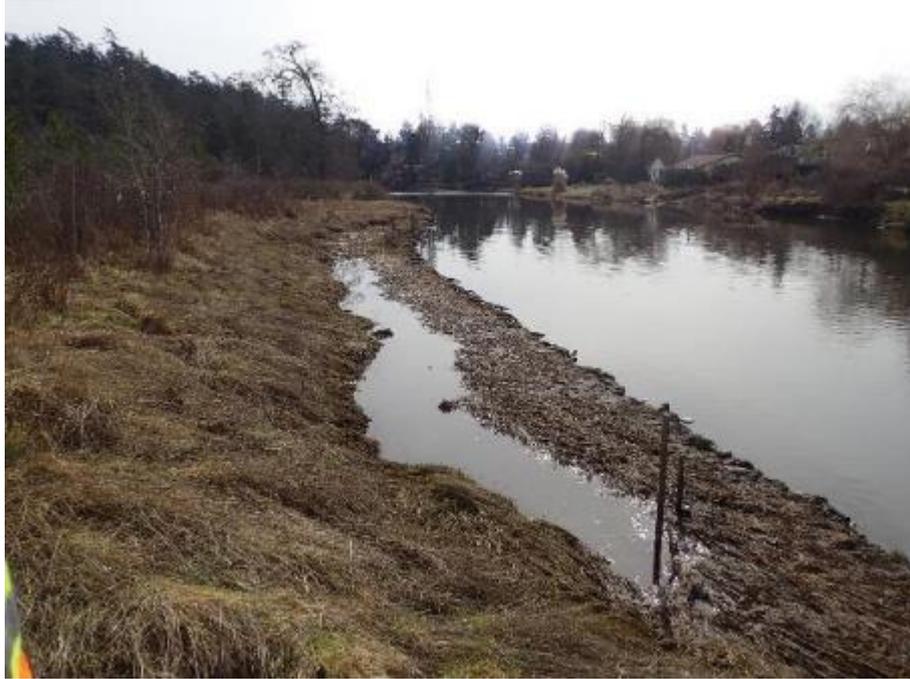
Upstream view along the gabion basket and previous riparian replacement zone. The intertidal vegetation established on the gabion basket bench is dominated by native species and provides a template for establishing nearby discrete tidal marsh benches.

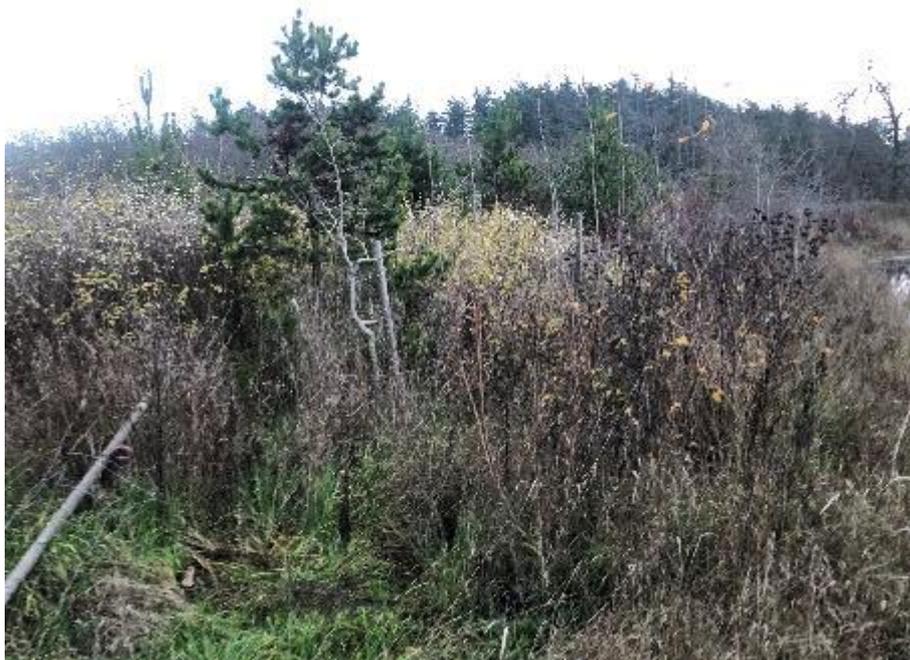
Colquitz River Admirals Bridge riparian planting compensation site on CHP. The surviving plantings provide a partial template for selection of native plantings. There are various other adjacent locations that could benefit from more diverse native riparian planting and weed control, possibly as McKenzie I/C riparian replacement.

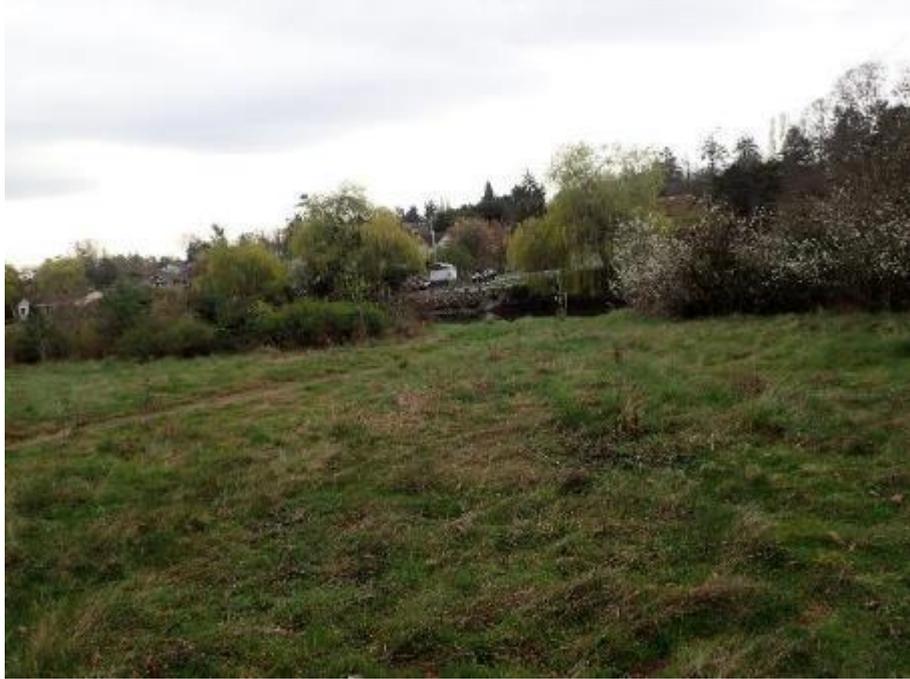
View from the largely open meadow zone toward the gabion basket riparian replacement area. The gap between the shrub patches are targeted for soil placement and native vegetation fill plantings.

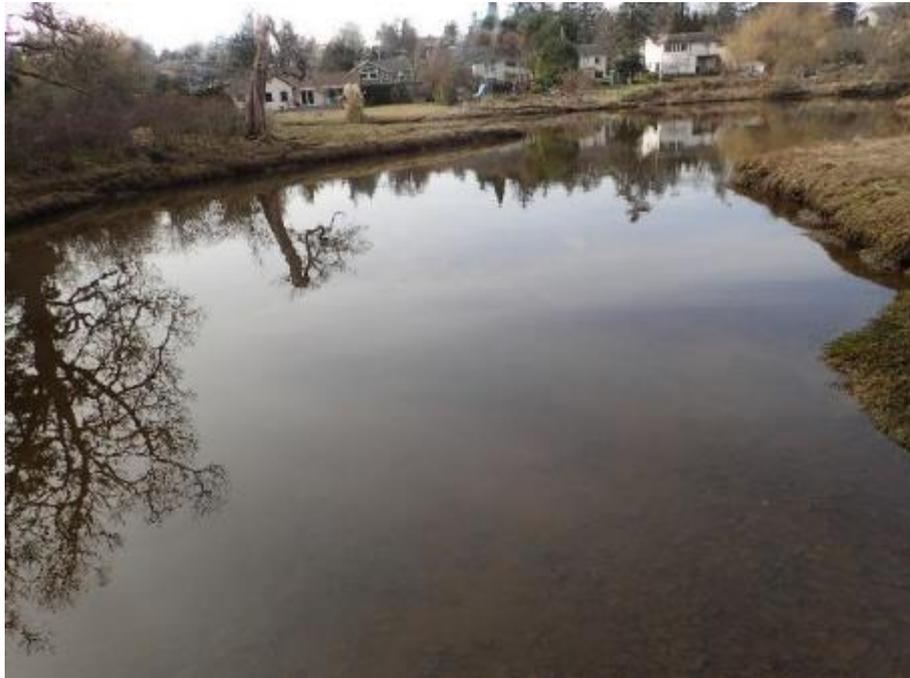
On probing the mud sediments, a distinct hydrogen sulphide odour was detected, so it is expected the sediments are anoxic and not as hospitable to biological life compared to a substrate that would have increased flow exposure, like gravel.

View along tidal mudflat from MIC parcel outfall and toward Colquitz River confluence. Initial probing showed ~30-50cm organic layer and with noticeable hydrogen sulphide odour when disturbed it is likely the sediments are anoxic. There was no noticeable rooted vegetation growing on this mudflat. Excavation and removal of these sediments, using them as an enhanced riparian planting medium and creation of raised tidal marsh fingers and small islands will platforms to enable vegetated marsh benches with improved substrate for benthic invertebrates, increased flow and dissolved oxygen through the substrate, additional microbial life that increases water quality biological treatment and biodiversity. Woody debris could also be added (partially buried), and because importation of oyster shells is planned for the MIC outfall treatments, some could be added to augment constructed benches to benefit water

quality by further mineralization and precipitation of metals, while adding beneficial components for aquatic organisms and brackish marine estuaries. Further assessment will occur prior to pursuing restoration in this zone.

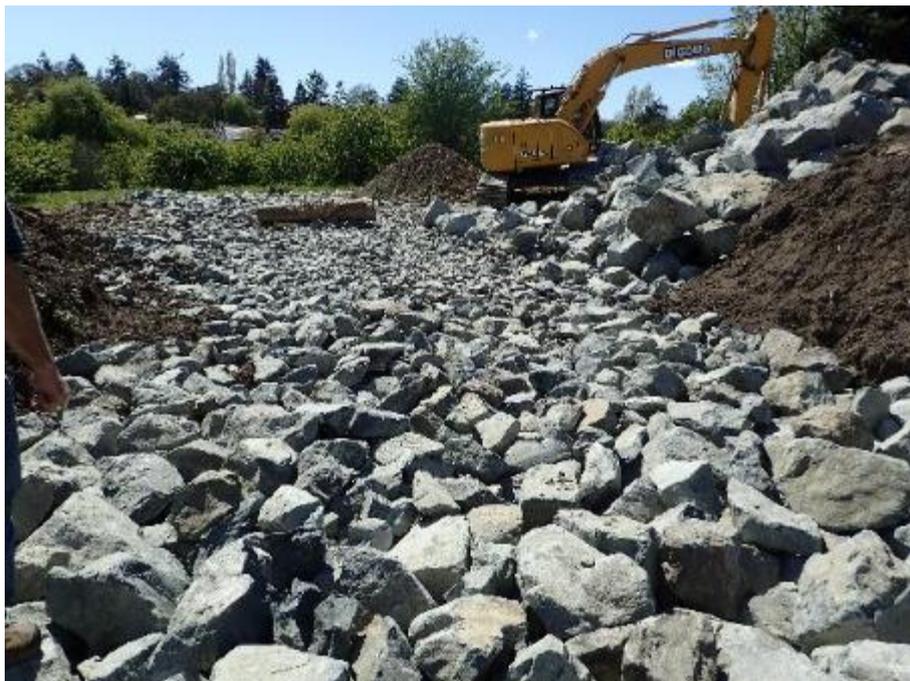
The sub-grade base of the temporary access, stockpile and staging area was built with coarse blast rock and capped with pit run gravel. Because this provides a porous soil profile, it could be used as an infiltration basin below a rain garden feature as some of this area is decommissioned and reclaimed. Organic strippings are salvaged for re-use in riparian planting areas.
